# Salon Space Microclimatic Indicators Evaluation of the Low-floor Bus

Yurii Voichyshyn, Kostyantyn Holenko, Orest Horbay and Anatolij Vychavka

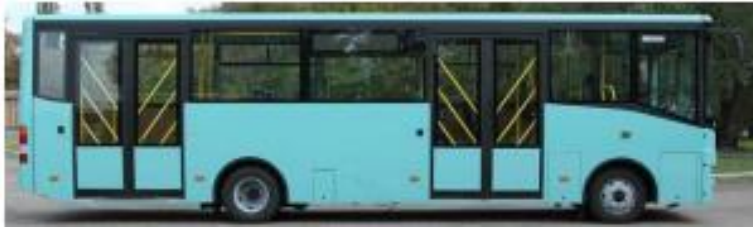
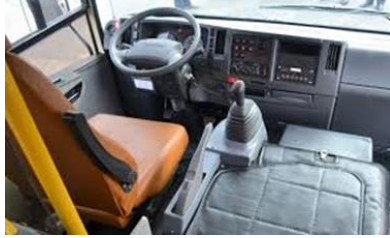
front with a compartment in the interior

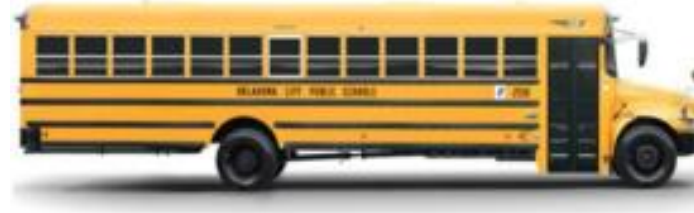
front with hood layout

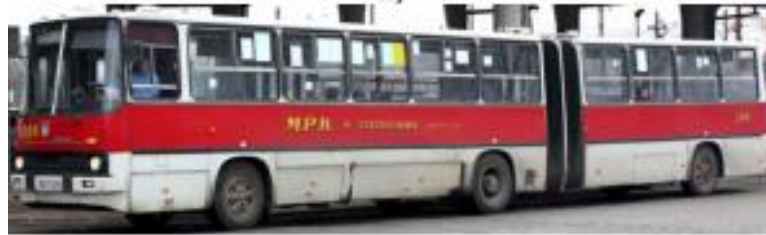
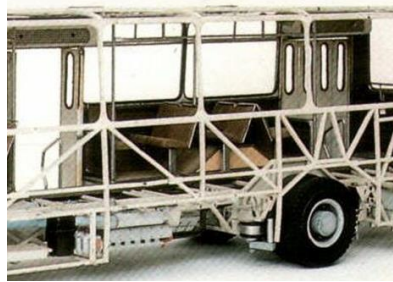
middle horizontally under the floor

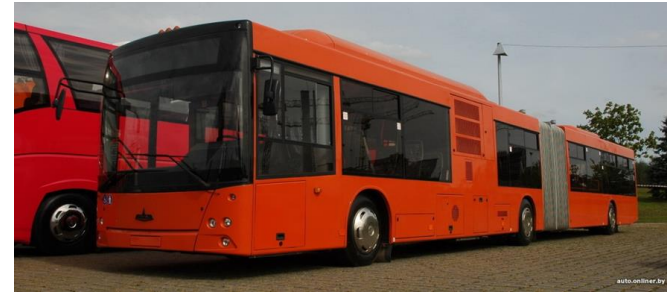
middle vertically

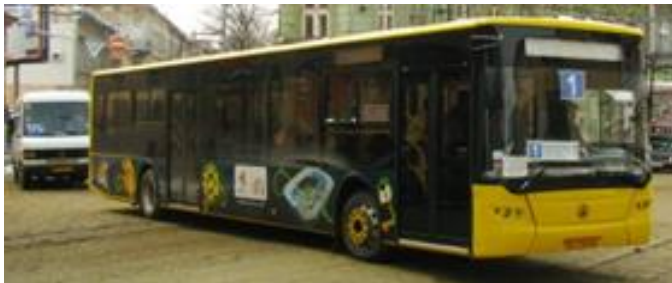
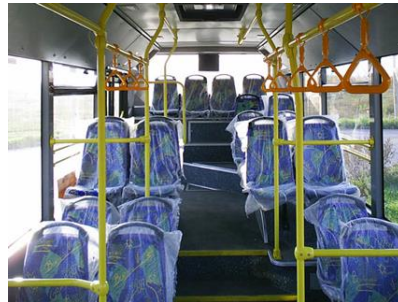
horizontally under the rear seats

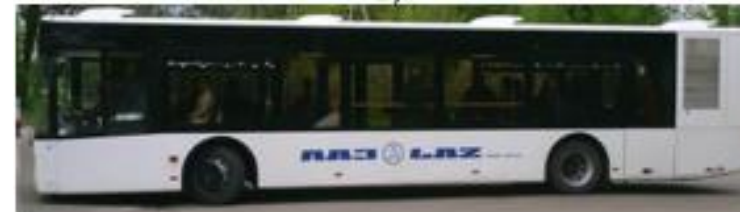
rear vertically with an offset to the left

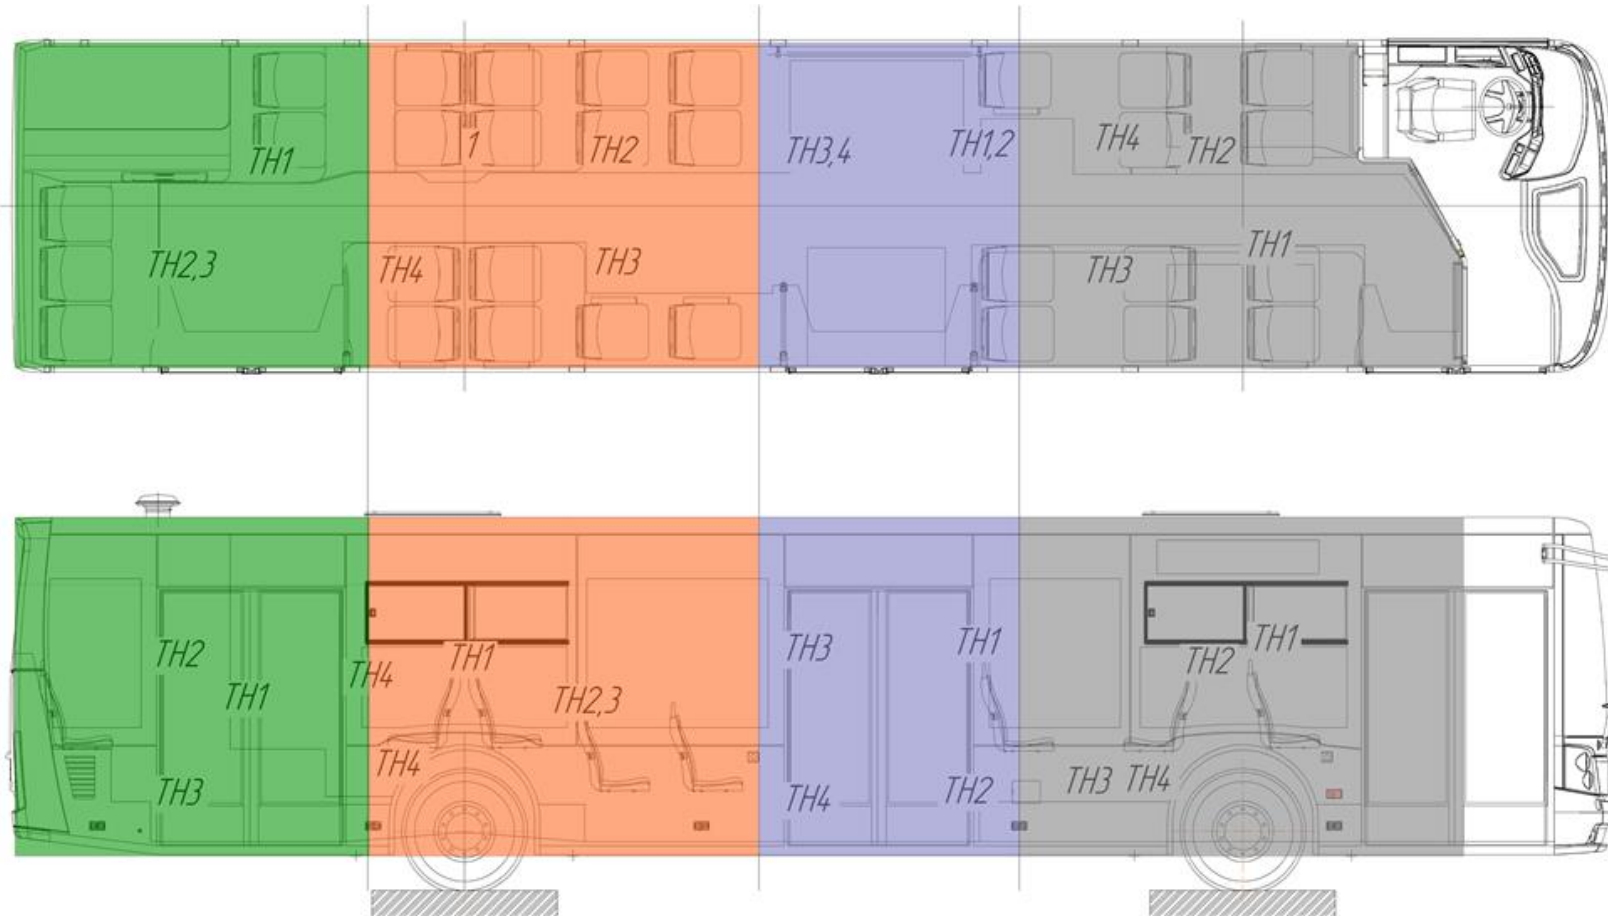
# The layout of temperature and humidity measurement points

#1 – between the wall of the driver's cabin and the storage platform;

#2 – in the area of the storage area;

#3 – between the storage area and the back door;

#4 – in the area of the back door.

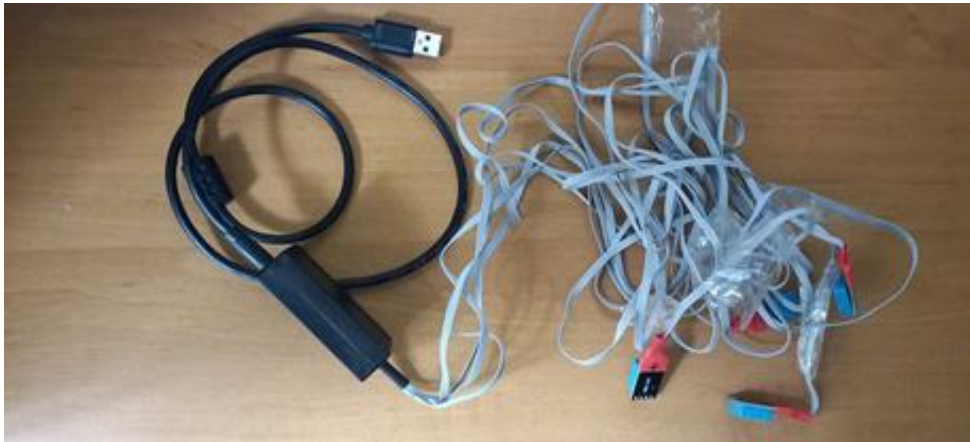
temperature and air humidity measuring device

The sensor provides temperature and humidity indicators with accuracy to one decimal place, which is its advantage compared to similar ones. This sensor can measure relative humidity (RH) values in the range of 20–90% and temperature in the range of -25 to 50°C. The sampling period of the sensor is 1 s.

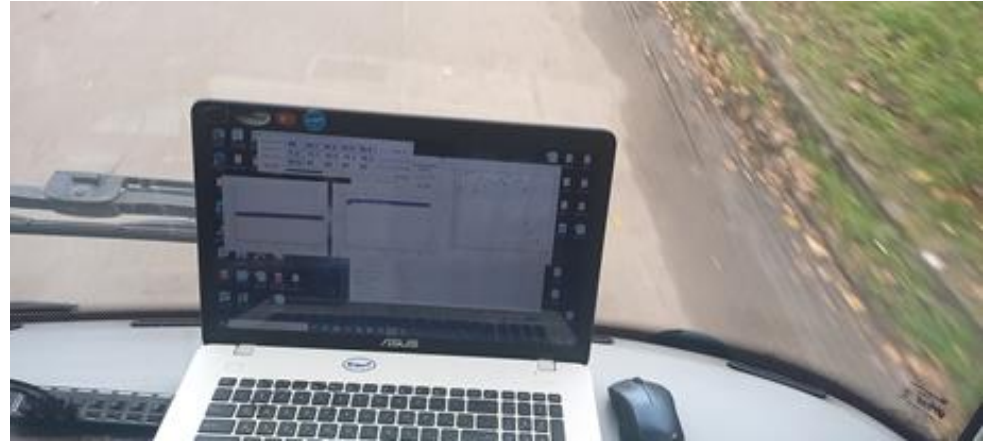
connected laptop with the custom software

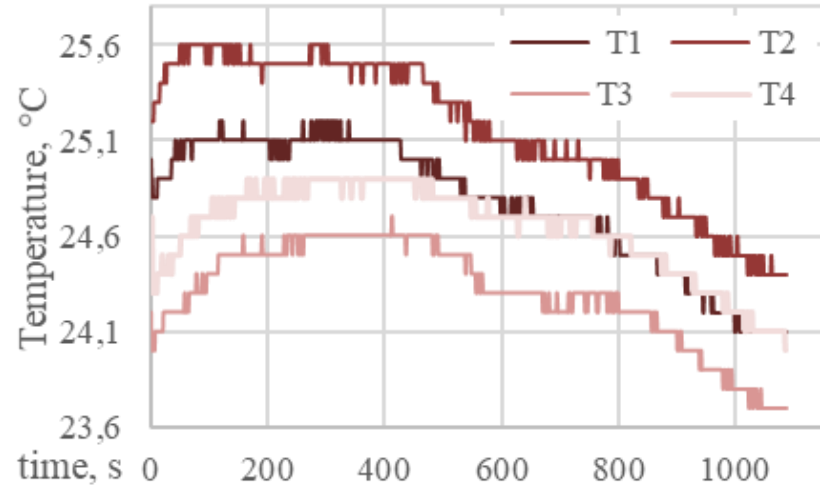
Zone 1

# EXPERIMENTAL RESULTS (temperature)

As follows from the studies conducted, the issue of organizing the microclimate of the interior of large vehicles remains relevant and in many aspects unresolved, requiring rationalization measures. It was established during the experimental studies that there are points in the bus salon where the microclimate indicators do not correspond to the normative values (zone #1 – TH1 and TH2 temperature – 24-25,50C, humidity all the points – 72-77%, zone #2 – TH4 temperature – 24-24,50C. Humidity all the points – 77-82%, zone #3, #4 – all the points – 29-360C and 21-38%). It follows that the existing salon ventilation system needs further development both analytical and experimental to verify the modeled CFD results in turn. The obtained experimental data can serve as a basis for further optimization of the interior configuration to improve microclimate indicators. The introduction of additional ventilation channels in zone #4 (rear overhang near the engine zone) looks especially relevant taking into account 30-36°C in this location.

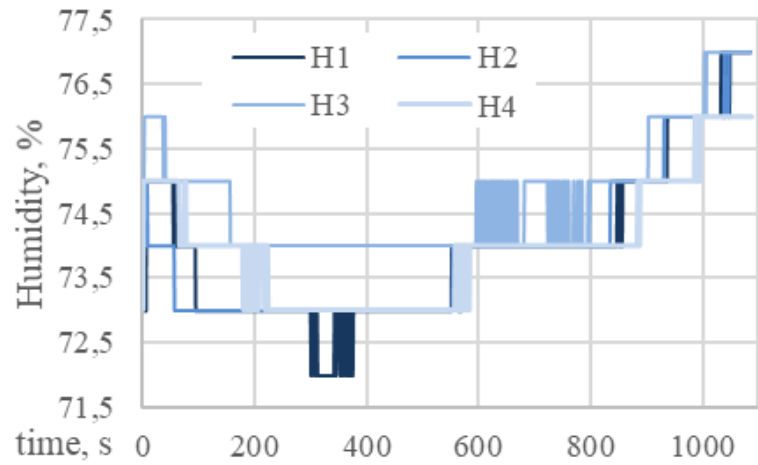
## Zone 1

# EXPERIMENTAL RESULTS (humidity)
